USE OF GEOMEMBRANES IN BUREAU OF RECLAMATION CANALS, RESERVOIRS, AND DAM REHABILITATION

**December 1995
Technical Service Center**

**U.S. Department of the Interior
Bureau of Reclamation**

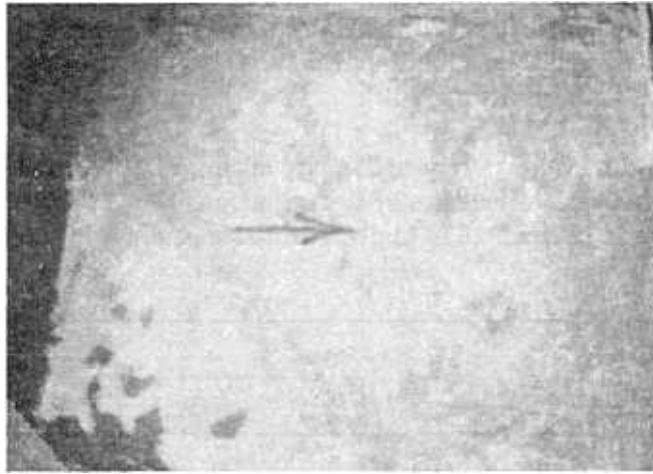
Figure 41. - View of exposed PVC membrane lining (sample No. 21418) at station 1330+00, below waterline. Photograph taken spring 1984. Helena Valley Canal, Montana.

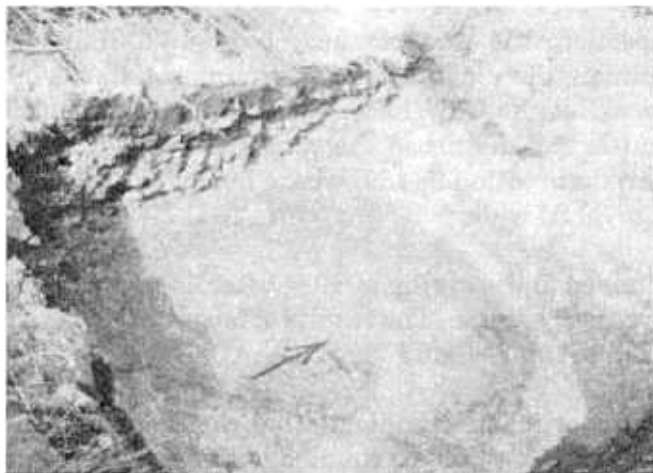
Figure 42. - Close-up view of exposed PVC membrane lining at station 1330+00, below waterline. Photograph taken spring 1984.

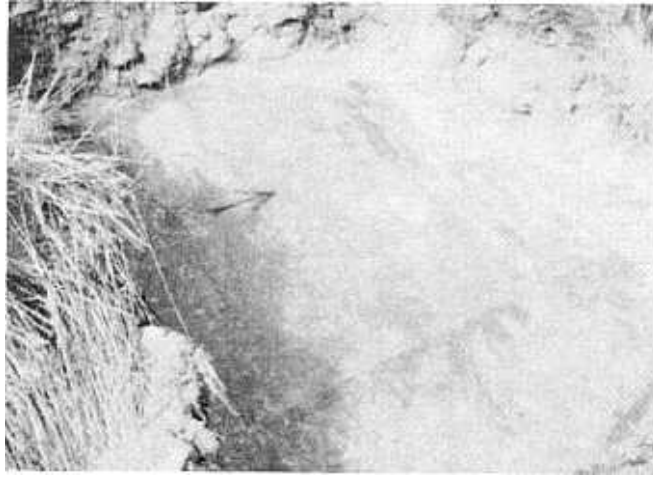
Figure 43. - View of exposed PVC membrane lining (sample No. 21419) at station 1330+00, above waterline. Photograph taken spring 1984. Helena Valley Canal, Montana.

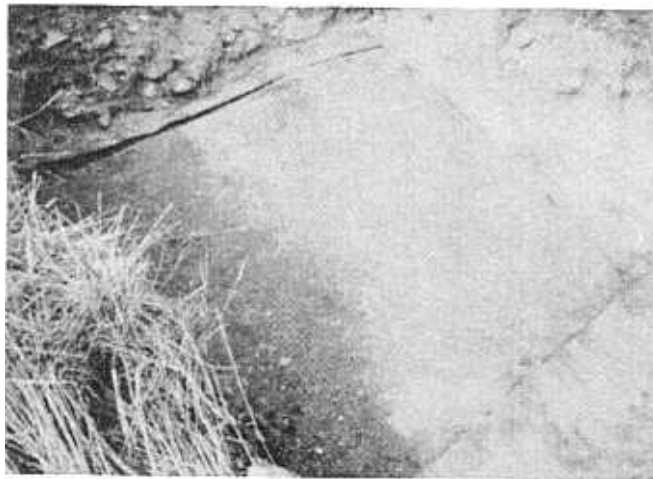
Figure 44. - View of subgrade at station 1330+00, above waterline. Photograph taken spring 1984. Helena Valley Canal, Montana.

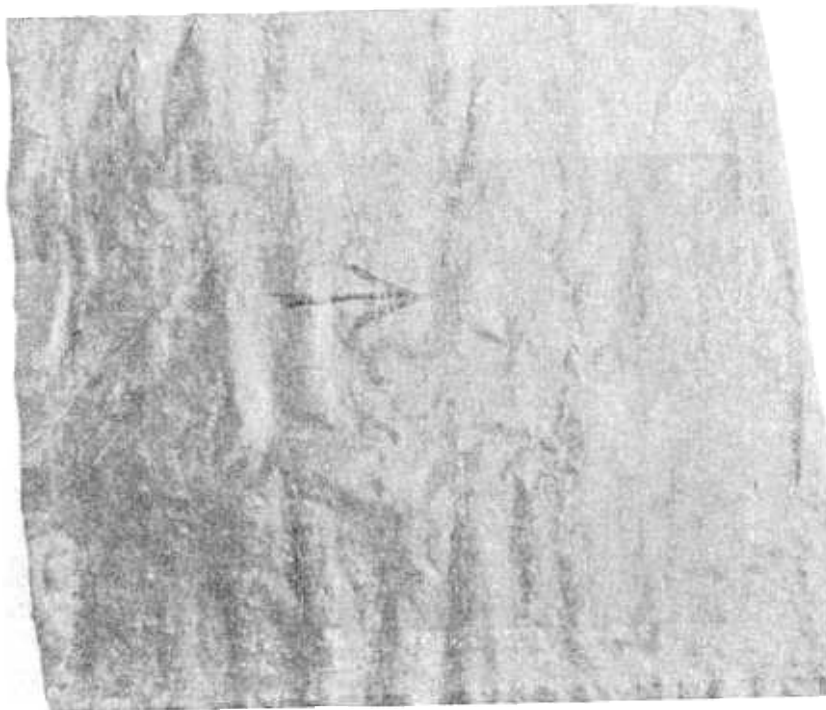
Figure 46. - View of 15-year-old field sample No. 21419.

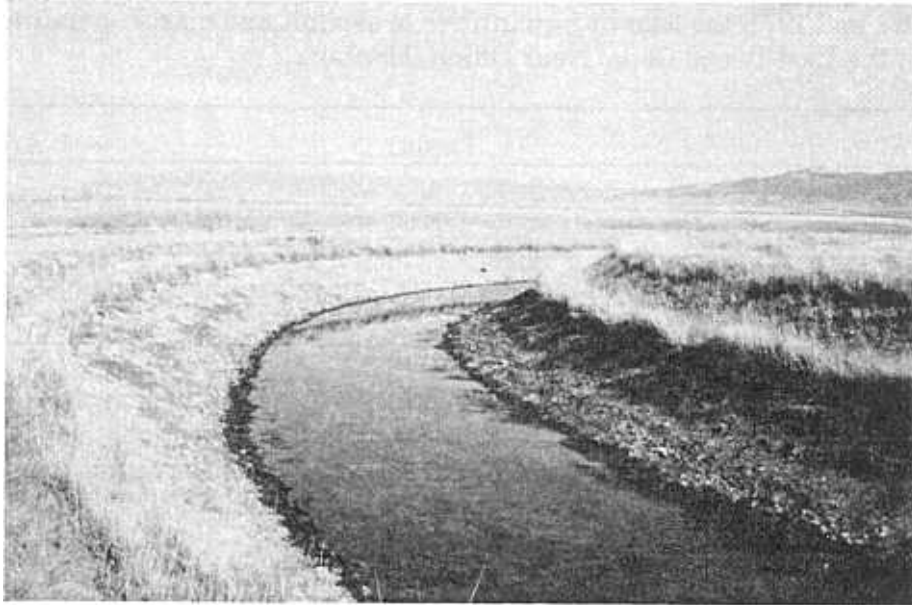
Figure 49. - East Bench Canal looking downstream from station 900+00 showing general condition of the canal in the vicinity of where PVC lining samples were taken. Photograph taken October 20, 1983.

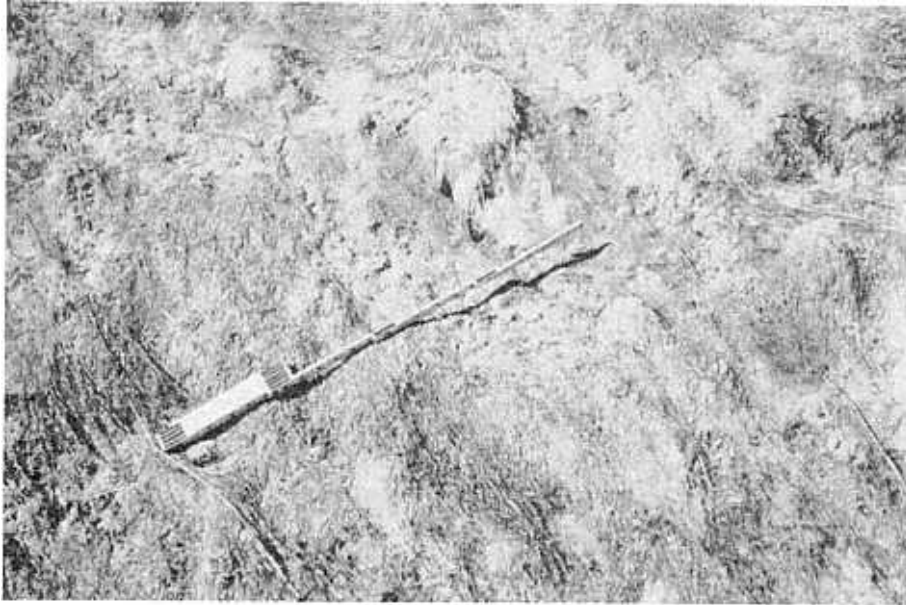
Figure 51. - Closer view of cover material at station 902+25 where samples of PVC lining were taken.

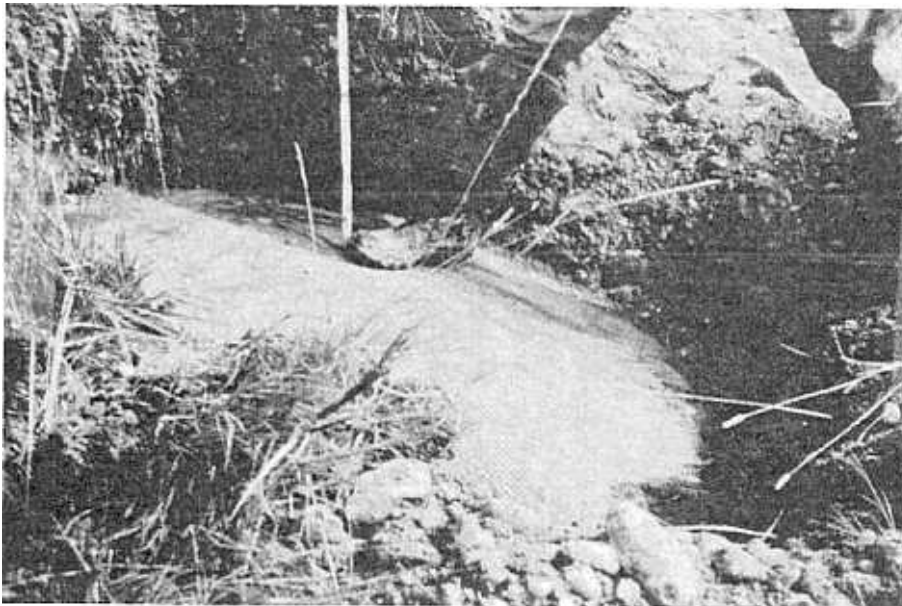
Figure 52. - View of exposed upper lining sample No. 21211 showing lining, depth, and condition of cover material. Station 902+25. Photograph taken October 20, 1983.

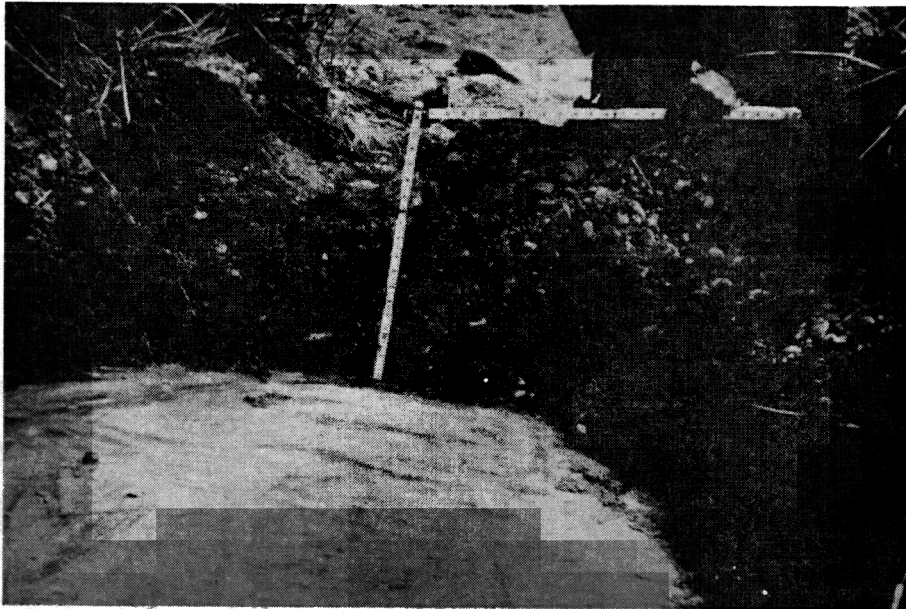
Figure 54. - View of exposed upper lining sample again showing depth of cover material. Station 902+25. Photograph taken October 20, 1983.

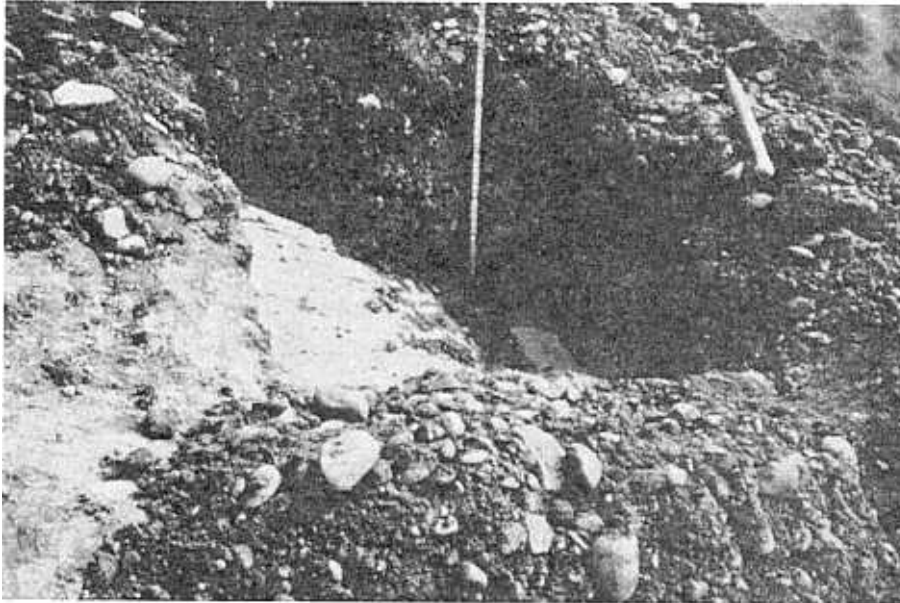
Figure 55. - View of exposed lower lining sample No. 21210 showing depth and condition of cover material.

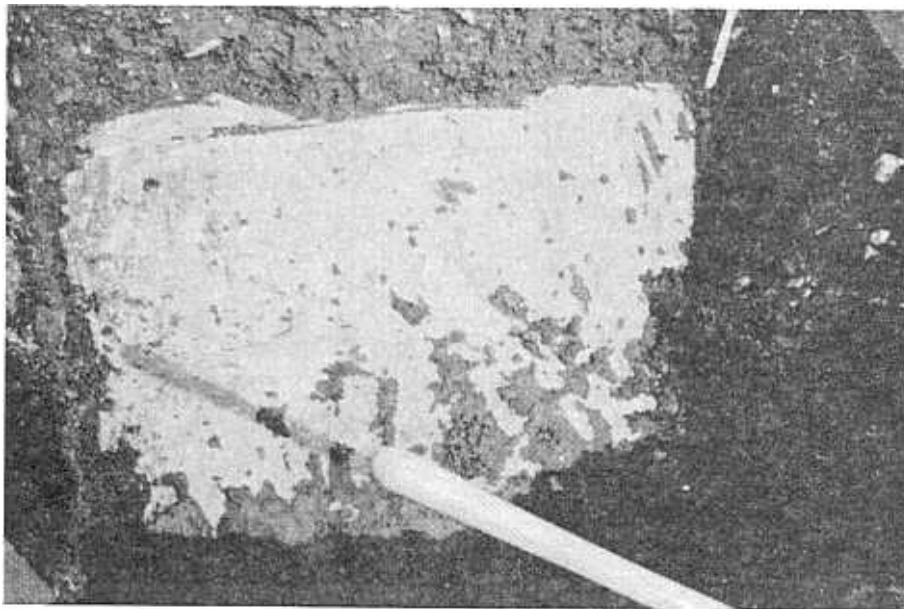
Figure 56. - Close-up view of exposed lower lining sample No. 21210 in place, depth, and condition of cover material. Station 902+25. Photograph taken October 20, 1983.

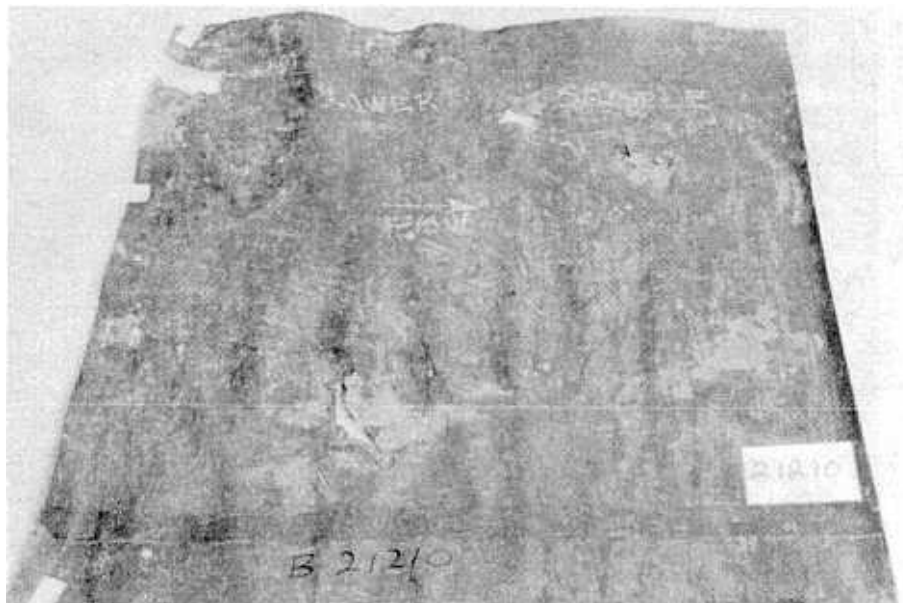
Chemical extraction tests indicated a plasticizer content of 18.5 percent (by weight) and 20.5 percent for 14-year-old samples. On the basis of the original plasticizer content of 33.2 percent, the plasticizer content was 44 percent and 38 percent lower. This result compared to a 37 percent loss for the 8-year-old sample taken from the same location. Therefore, it appears that very little plasticizer loss has occurred between 8 and 14 years of service. The loss of plasticizer with time is shown on figure 59.

Figure 57. - View of 14-year-old field sample No. 21210.

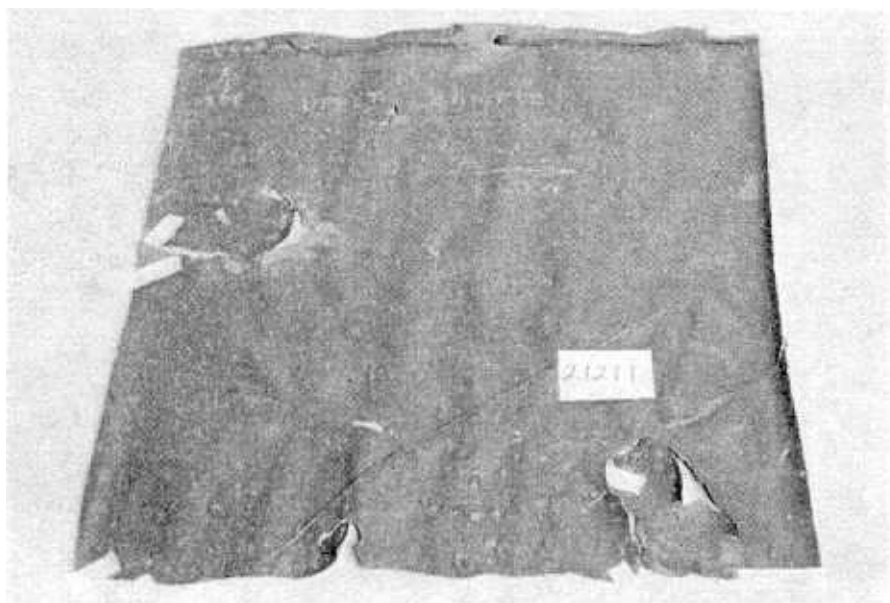
"The lining in place was in excellent condition with no holes or tears. The tears in the samples are a result of not exercising enough care when removing the cover material.

Figure 58. - View of 14-year-old field sample No. 21211.

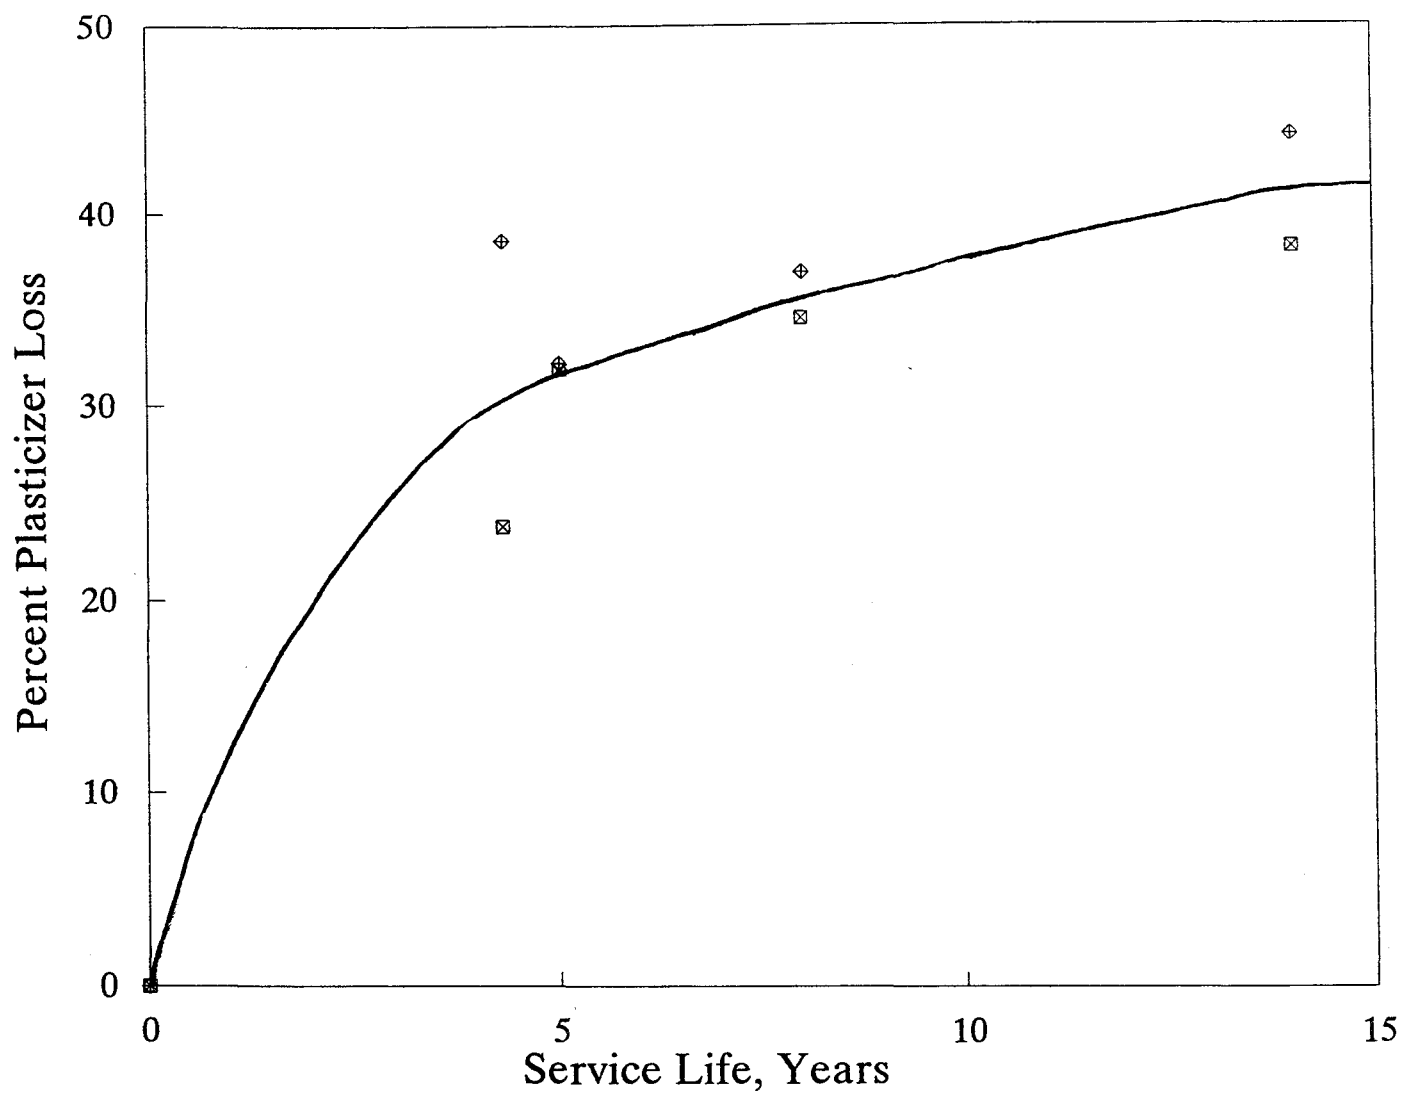
Figure 59. - Percent plasticizer loss (by weight) for PVC plastic lining samples obtained from below normal waterline on the East Bench Canal, Montana.

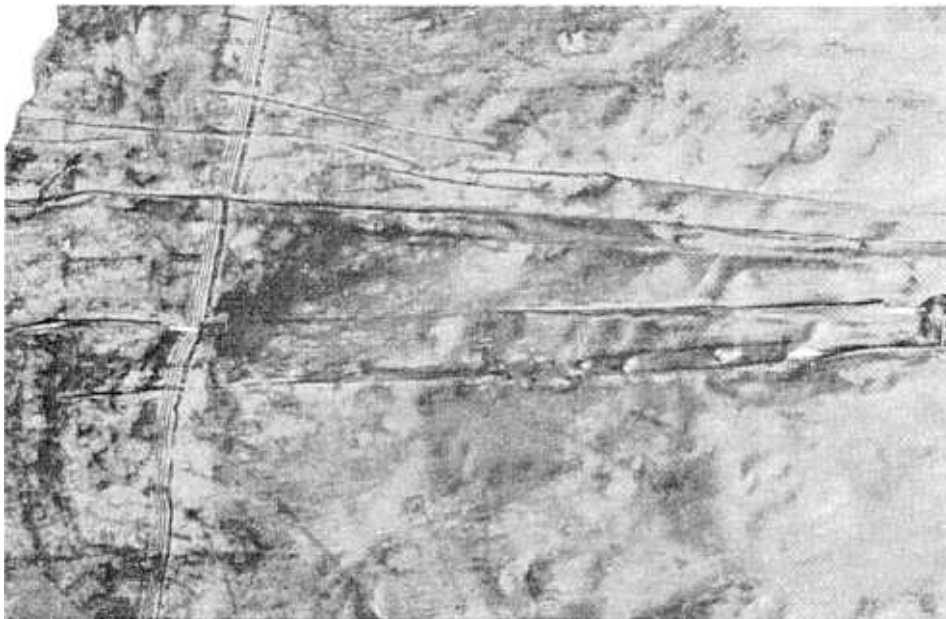
Because the 27-year-old sample contained several folds as shown on figure 62, tensile tests were conducted on several specimens from the folds for comparison to those from the unfolded portion. Test results shown below indicated that the folds had no adverse effect on the tensile properties.

Figure 62. - View of 27-year-old field sample (22497) obtained in 1988. Sample had four folds running at a right angle to the factory seam.

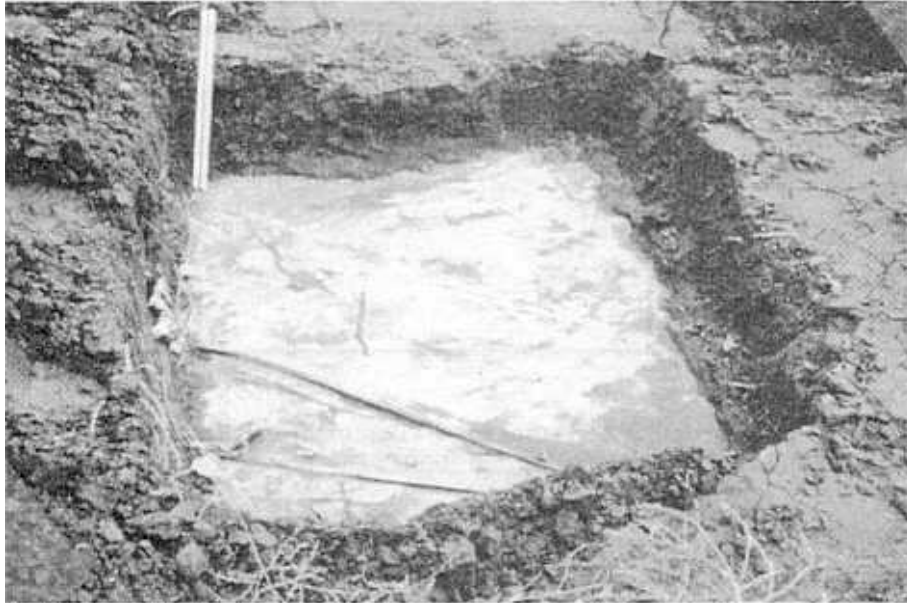
Because the installation was in a curved reach of the canal, some folding and wrinkling were necessary on the inside of the curve and in the bottom, which may account for the folds shown on figure 64.

Figure 63. - View of 0.2-mm (8-mil) PVC geomembrane installed in test section on Kennewick Main Canal, Kennewick Irrigation District, Washington, in December 1959. Photograph was taken in February 1991 after 31 years of service. Note folds in lining because of installation around a curve. Depth of soil cover is about 200 mm (8 in).

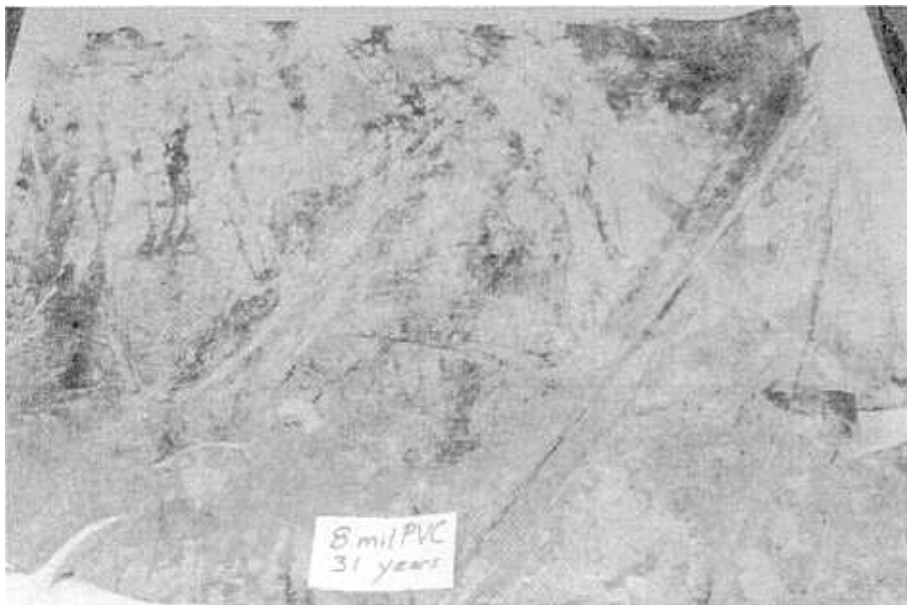
Figure 64. - Laboratory photograph of sample (23203) shown on figure 63. Tears in lining were made by shovels during removal of soil cover.

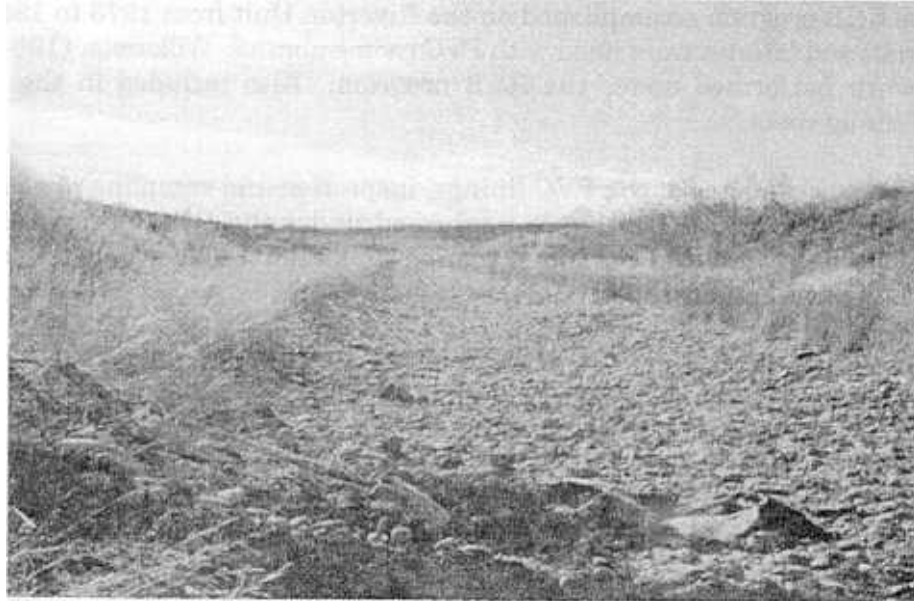
Figure 65. - View downstream from sample site at station 103+96. Photograph taken fall of 1984. Fivemile Lateral, Riverton Unit, Wyoming.

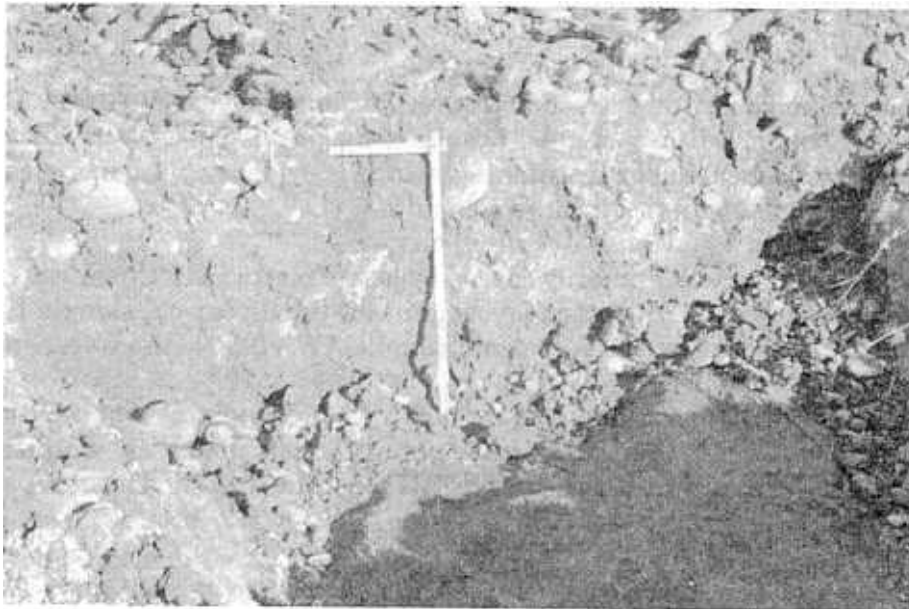
Figure 66. - View of exposed 0.25-mm (10-mil) PVC membrane lining (sample No. 21620) at station 103+96, canal invert. Photograph taken fall 1984. Fivemile Lateral, Riverton Unit, Wyoming.

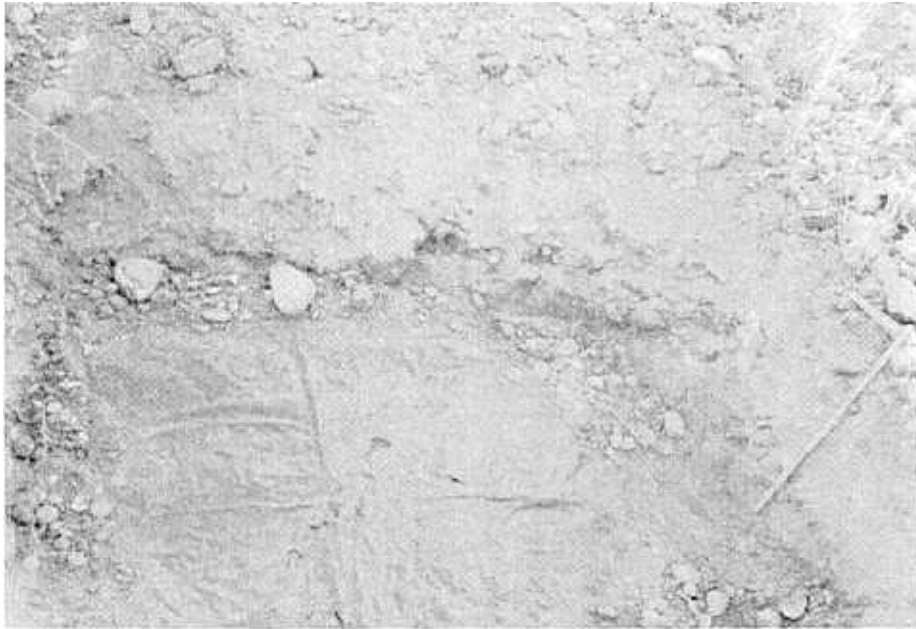
Figure 67. - View of exposed 0.25-mm (10-mil) PVC membrane lining (sample No. 21621) at station 103+96, above waterline. Photograph taken fall 1984. Fivemile Lateral, Riverton Unit, Wyoming.

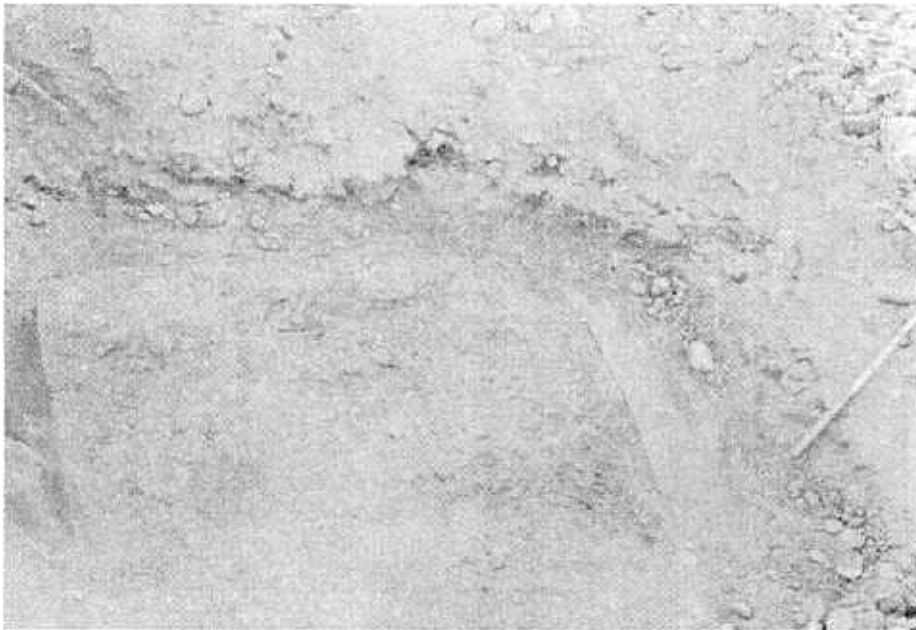
Figure 68. - View of subgrade, above waterline, at station 103+96. Photograph taken fall 1984. Fivemile Lateral, Riverton Unit, Wyoming.

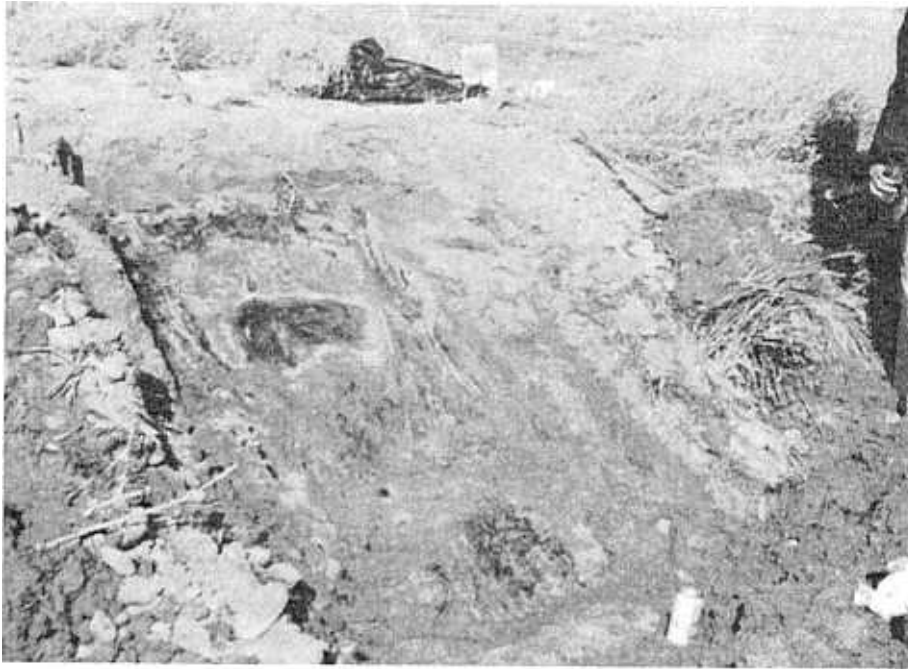
Figure 69. - View of exposed 0.50-mm (20-mil) PVC membrane lining at station 309+70. Photograph taken fall 1985. Fivemile Lateral, Riverton.

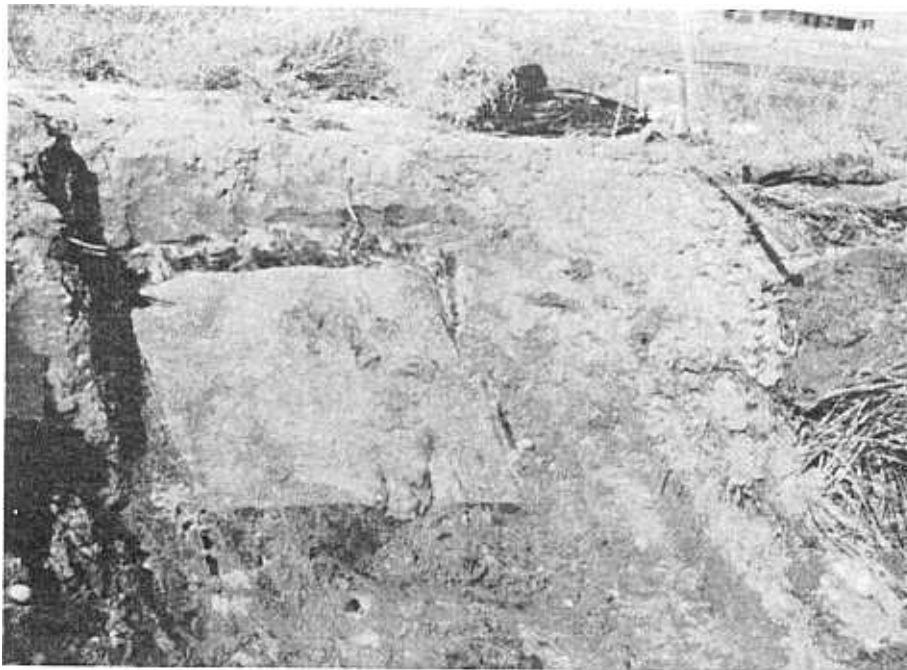
Figure 70. - View of subgrade at station 309+79. Photograph taken fall 1985. Fivemile Lateral, Riverton Unit, Wyoming.

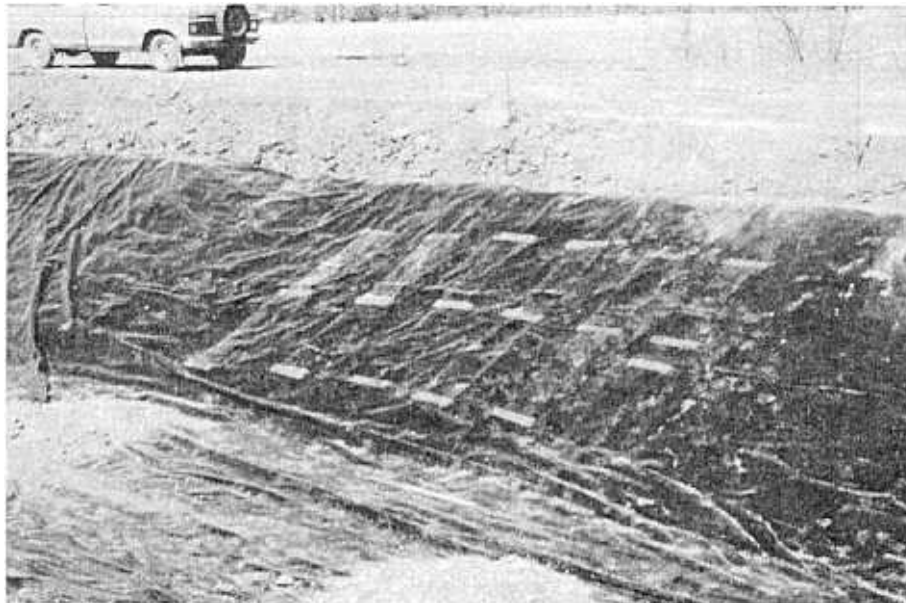
As part of the study, test coupons, each measuring about 0.3 by 1.5 m (1 by 5 ft), were installed on the side slope of the canal as shown on figure 77 to allow periodic retrieval for testing and evaluation. Test results for coupon samples retrieved after 1, 2, and 5 years of service are summarized in table 16. Results of these tests indicate that no apparent deterioration of the lining occurred.

Figure 77. - View of test coupons taped to lining on left slope, just upstream from station 528+00. The coupon samples measuring about 0.3 by 1.5 m (1 by 5 ft) were installed both above and below waterline and will be removed periodically for testing and evaluation.

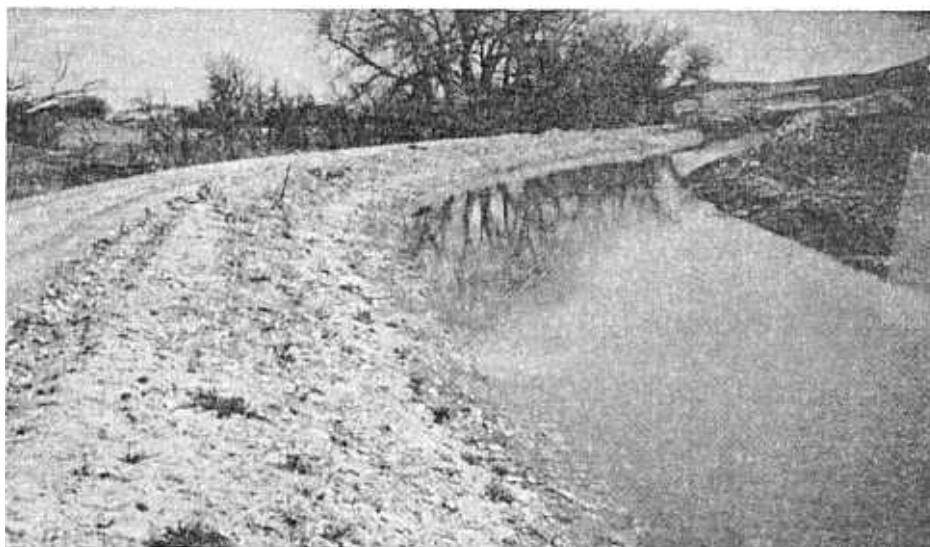
The canal was inspected in May 1988 after 1 year of service, as shown on figures 78 and 79, and again in October 1990, and no evidence of any problems with soil cover stability were found.

Figure 78. - Photograph taken May 1988 showing test section of VLDPE, South Canal, Belle Fourche Unit, South Dakota, after 1 year of service. View looking downstream. Steel post in center of photograph notes the change in cover material. Downstream, the cover material was 0.3 m (12 in) of pit-run gravel, and upstream, cover material was 150 mm (6 in) of excavated earth material and 150 mm (6 in) of pit-run gravel.

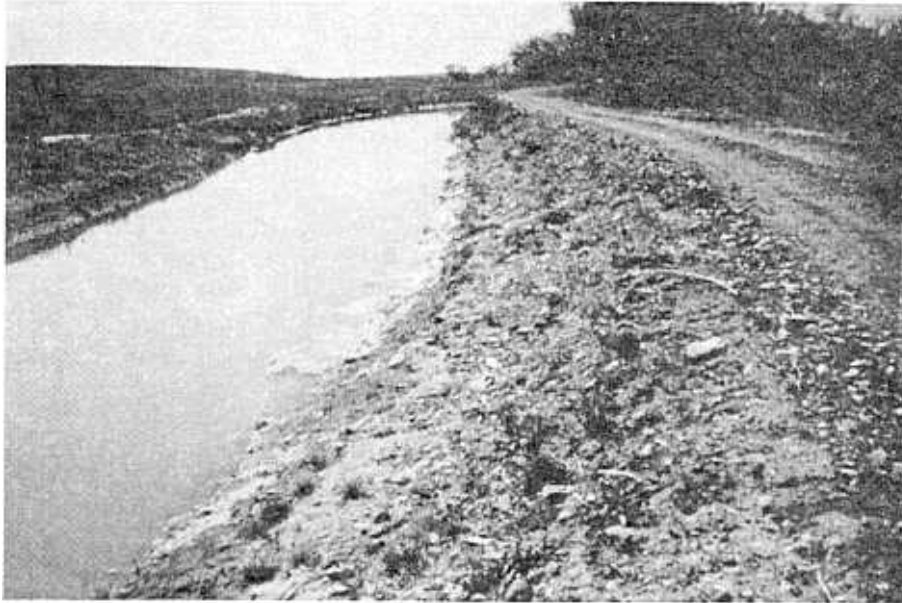
Figure 79. - View upstream looking at VLDPE test section where 150 mm (6 in) of earth and 150 mm (6 in) of gravel was used as the cover material. No evidence has been found of any problems with soil cover stability in the test section after 1 year of service.

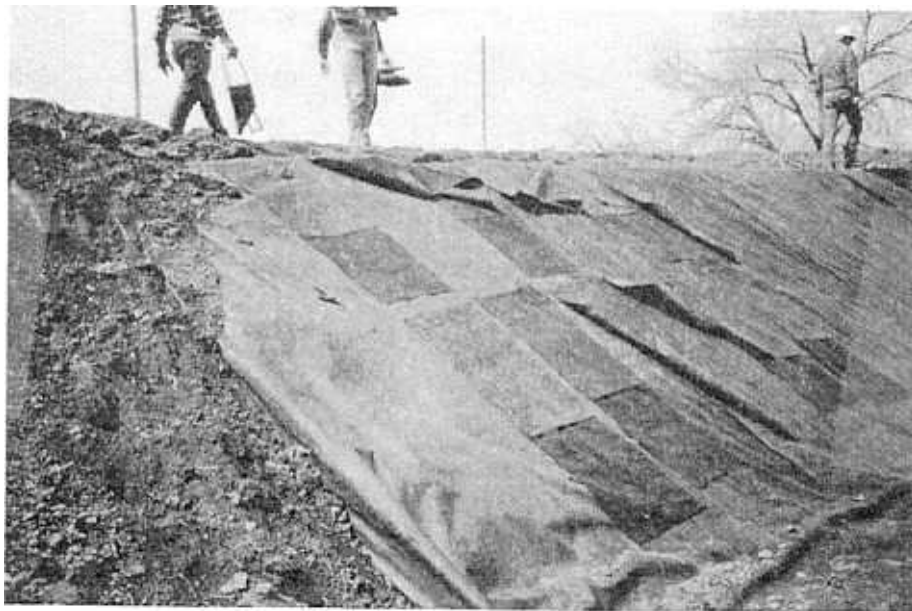
To monitor the performance of the lining, coupon samples were placed in the canal as shown on figure 87. These samples will be retrieved periodically for testing and evaluation.

Figure 87. - View of test coupons installed in canal to monitor performance of the polyolefin composite lining.

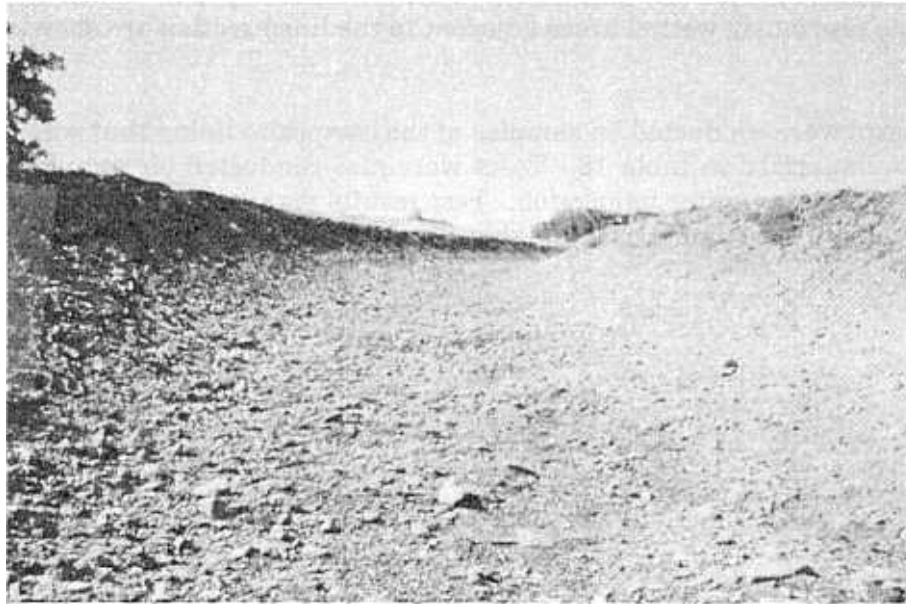
The canal was inspected in September 1993, at 3½ years old, after the irrigation season, and the soil cover appeared to have remained stable on the 1.5:1 slopes as shown on figures 88 and 89. Also, some previously wetted areas adjacent to the lined section are showing signs of less seepage.

Figure 88. - View of test section of polyolefin composite lining taken September 1990 after irrigation season. The soil cover has remained stable on the 1.5:1 side slopes.

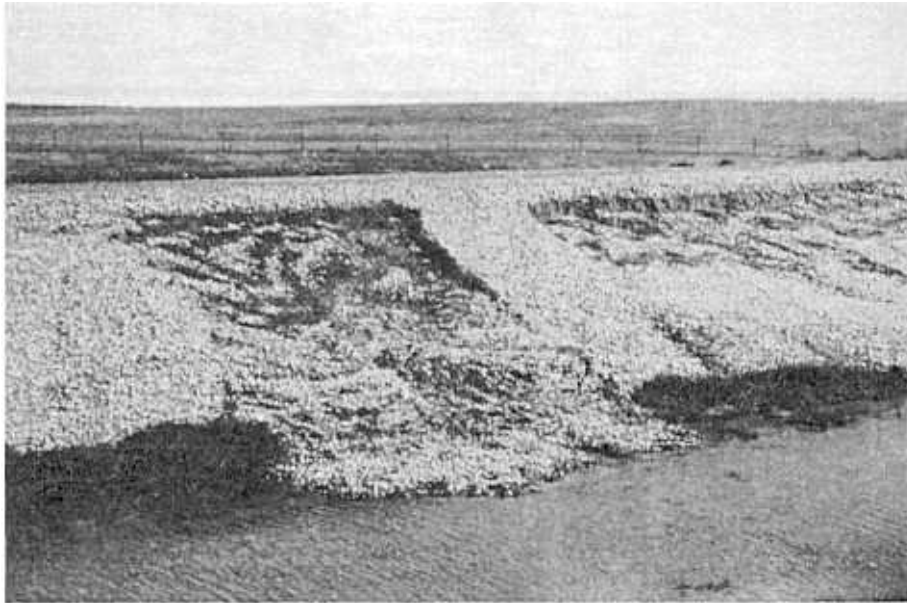
About 61 percent of the sloughs were considered type A, 21 percent type B, and 18 percent type C (table 24). Examples of these sloughs are shown on figures 95 to 97.

Figure 95. - View of protective soil cover slippage on New Rockford Canal, Reach 2, Garrison Unit, North Dakota. This slough has been classified as a type A: major slippage with movement onto the prism bottom. Photograph was taken in September 1991.

The contractor repaired the sloughs (at Government expense) by dragging cover materials back up the slope with their backhoe and regrading the slopes to the design dimensions.

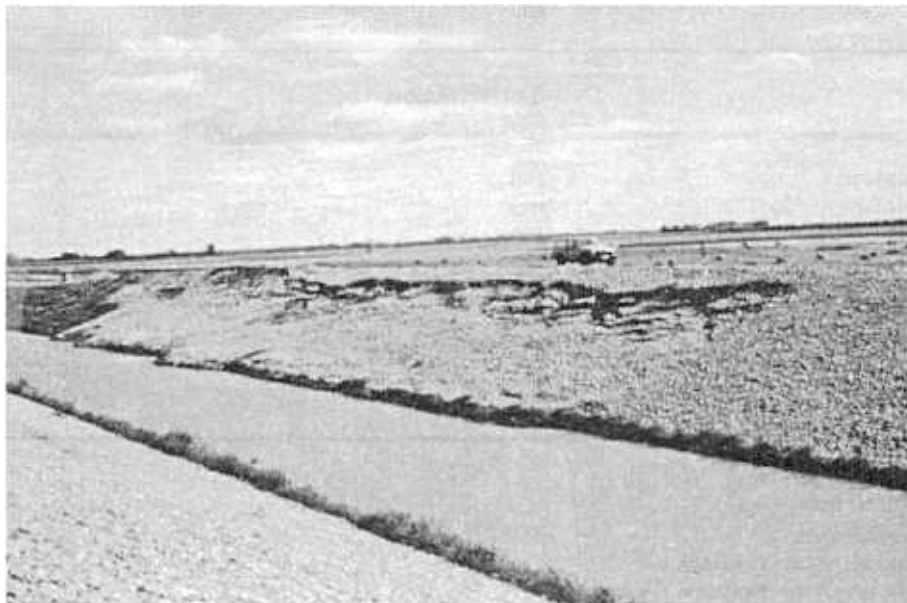
Figure 96. - View of protective soil cover slippage on New Rockford Canal, Reach 2. This slough has been classified as a type B: moderate slippage on the slopes only, bottom intact. Photograph was taken in September 1991.

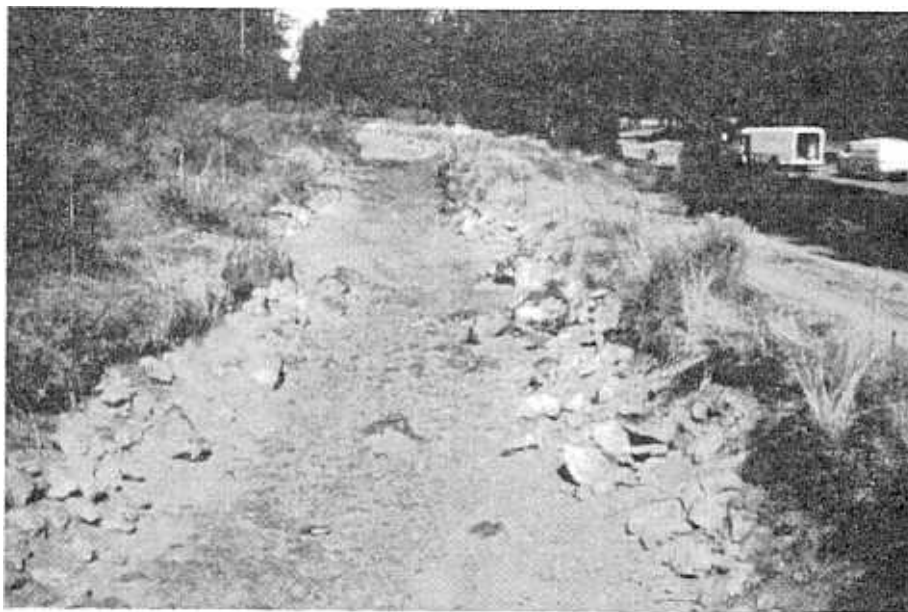
Figure 99. - View of subgrade conditions in Arnold Canal, Deschutes Project, Oregon.

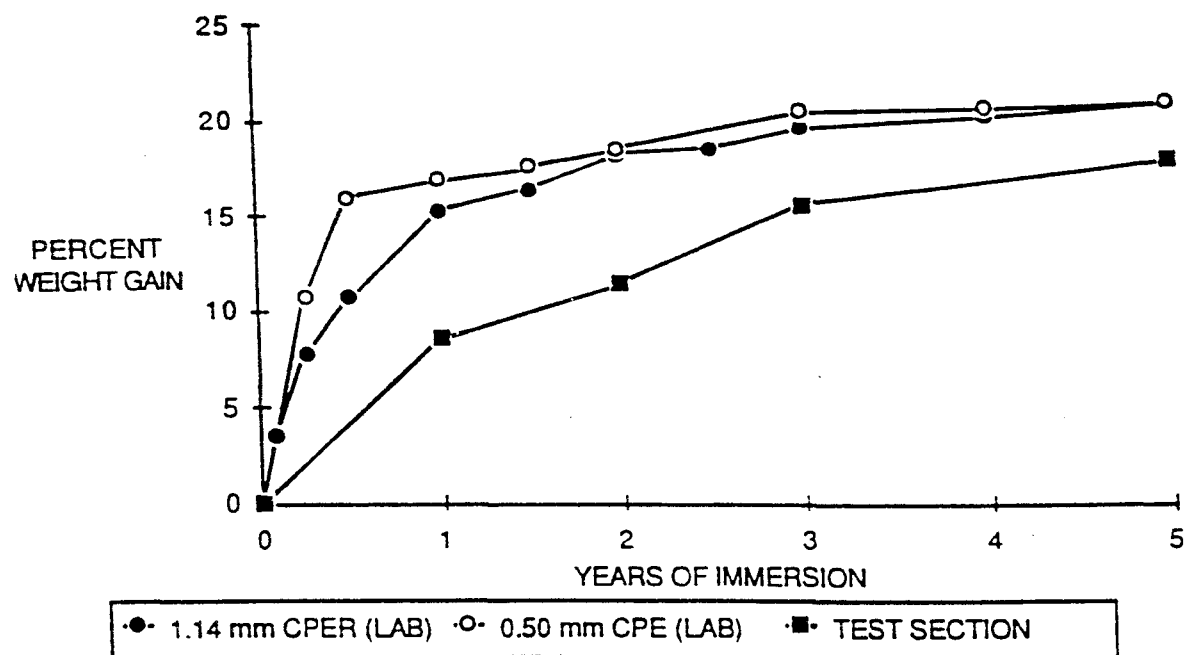
Results of studies conducted on the geomembrane installed in 1980 in the Mt. Elbert Forebay Reservoir indicate that the material is performing satisfactorily to date. Studies involve continuous monitoring of instrumentation on the hillside between the forebay reservoir and powerplant, and periodic retrieval of coupon samples from the field test section for laboratory testing and evaluation. In addition, laboratory water immersion test results are summarized in tables 30 and 31 and shown graphically on figure 103.

Figure 103. - Moisture absorption - laboratory water immersion testing and Mt. Elbert test section results.

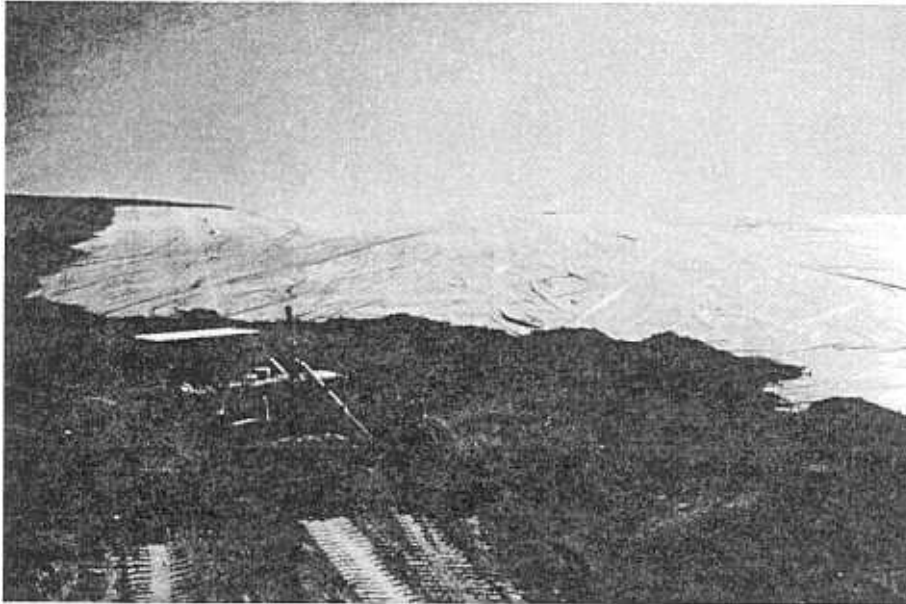
At installation, the thermal expansion of the geomembrane caused waviness, which led to some permanent folds in the liner when the protective soil cover was placed. This condition is shown on figure 108. Folded samples were included in the coupon monitoring section to determine the long-term effect of the creases on the performance of the geomembrane.

Figure 108. - Waviness led to some permanent folds in geomembrane after protective soil cover was placed.

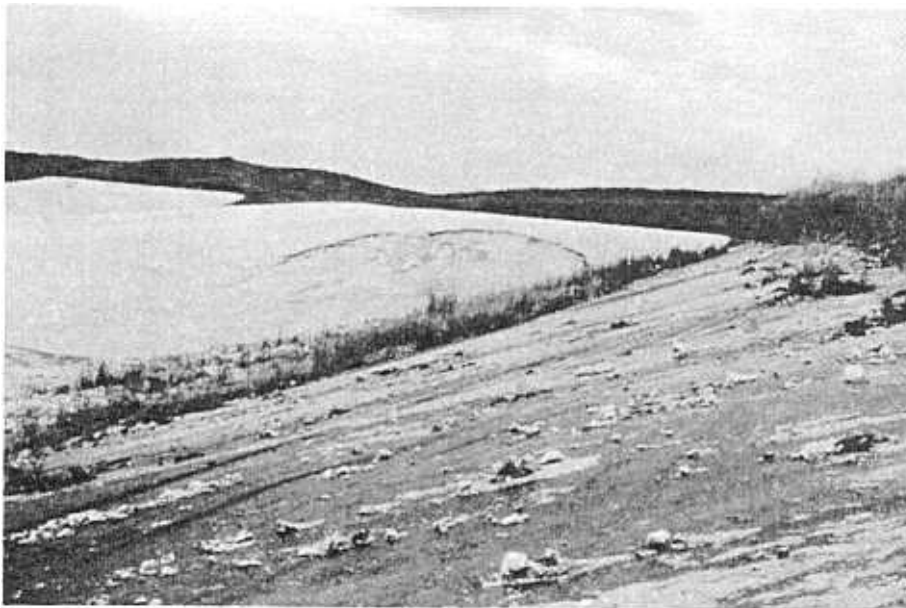
In 1986, an unusually heavy rainfall resulted in slippage of several portions of the protective soil cover (shown on fig. 109). In general, failures occurred on slopes steeper than 4H:1V.

Figure 109. - View showing slippage of protective soil cover.

During the summer of 1987, a remedial construction program was initiated to repair the exposed areas of geomembrane. Seven of the 8 areas were repaired by sandblasting the top surface of the exposed liner to enhance the frictional resistance, followed by covering it with a 0.15-m (6-in) layer of pervious sand and gravel bedding and a 0.3-m (12-in) layer of cobbles. For the remaining slide area, the existing geomembrane was removed and replaced with a textured HDPE geomembrane and covered with bedding and cobbles.

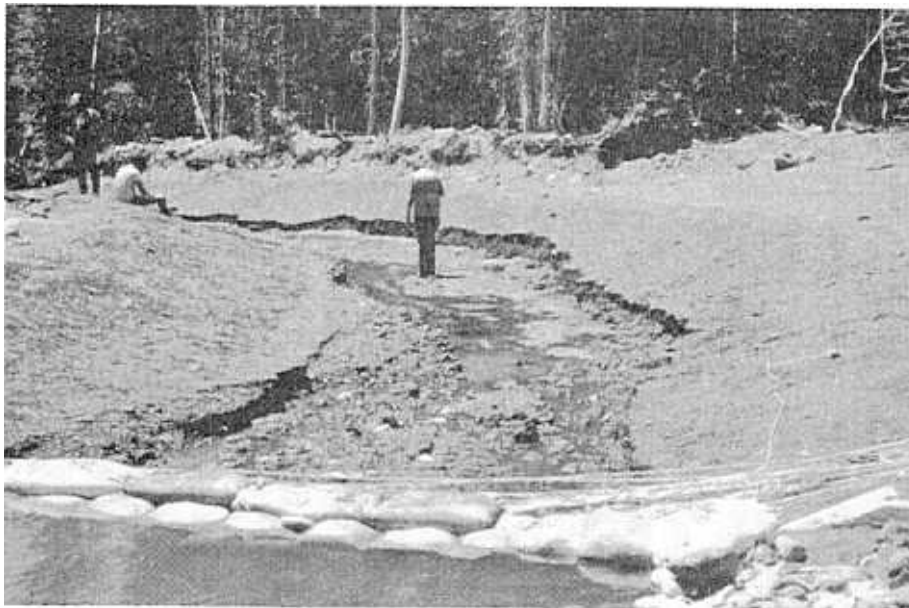
The field test installation was completed in the fall of 1985, and an operational test, as shown on figure 111, was conducted in 1986. The geomembrane, a 0.9-mm (36-mil) thick Hypalon (CSPE-R), performed as expected—quite well. During the initial flows over the spillway, the soil cover was washed away until the membrane on the bottom of the spillway was exposed. Even though the flow carried much abrasive material, stones, and a few cobbles about 100 mm (4 in) in diameter, little or no erosion or damage of the membrane was observed. The results of this study are discussed in Bureau of Reclamation report "Emergency Spillways Using Geomembranes" (1988d).

Figure 11 View of exposed membrane after field test of emergency spillway, Cottonwood Dam No. 5.
